**Visual Roof Evaluation Survey Report
North Dekalb Cultural Arts Center
Dunwoody, Georgia 30346**

April 3, 2012

Subject: Roof Condition Survey for North Dekalb Cultural Arts Center, Dunwoody, GA.

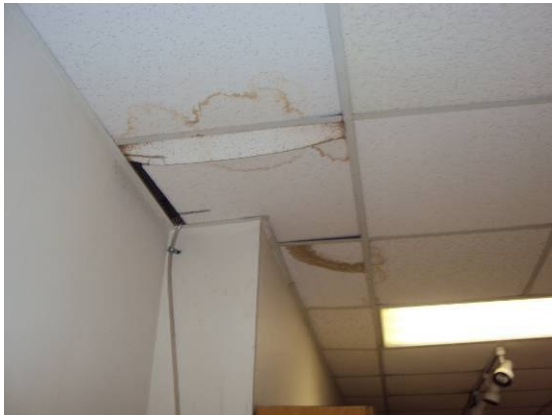
1. Stained ceiling tiles located below a roof drain on Roof Area B.

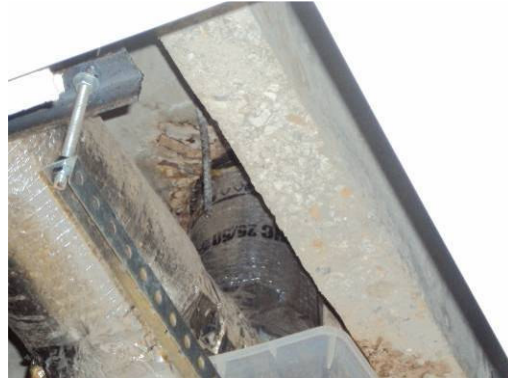
2. View of drain leader and concrete deck.

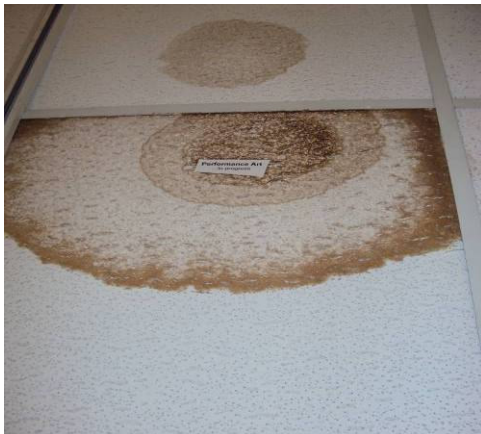
3. Stained ceiling tiles.

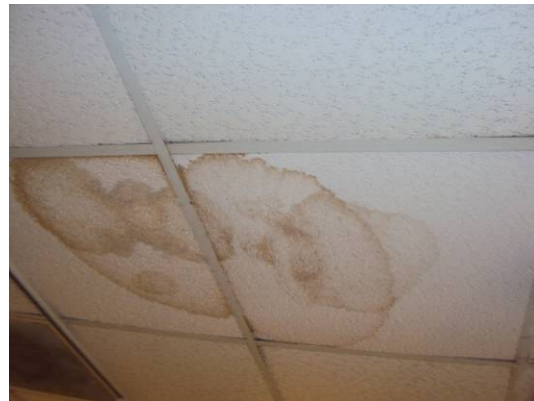
4. Stained Ceiling tiles located below Roof Area F. The previous tiles in this location collapsed and were replaced about a year ago.

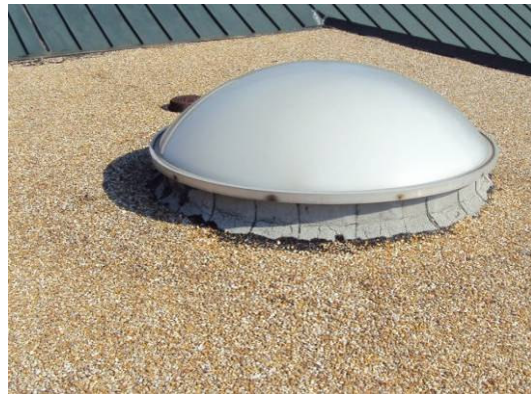
6. Some cracks are present in the skylight base flashing.

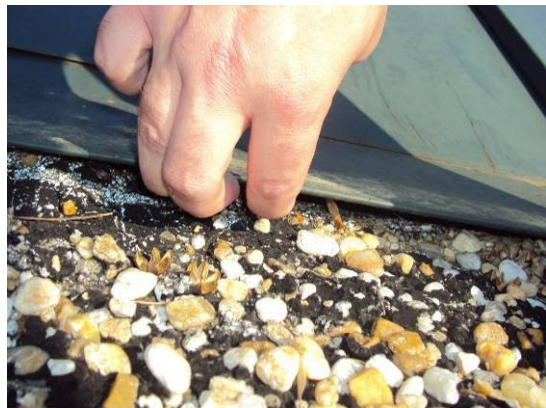
7. The base flashings between Roof Area A and the metal roof are non-existent. No sealant is present at this juncture.

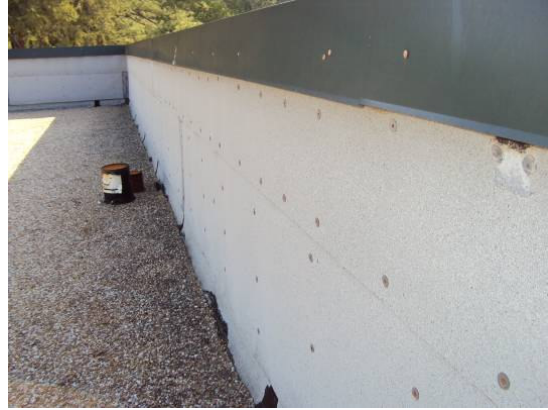
10. Exposed fasteners are installed through modified bitumen membrane flashings. Fasteners are rusted and deteriorated.

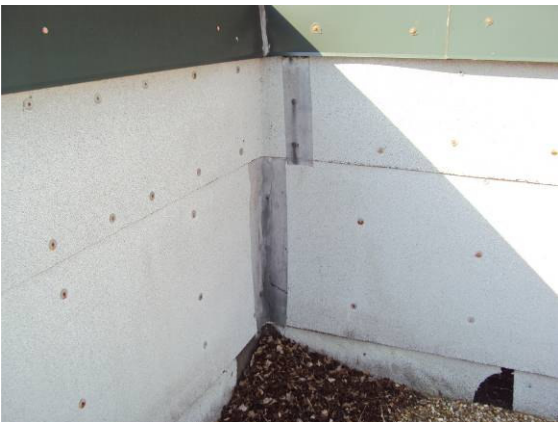
11. Repairs at base flashing laps. Exposed fasteners are installed through modified bitumen membrane flashings.

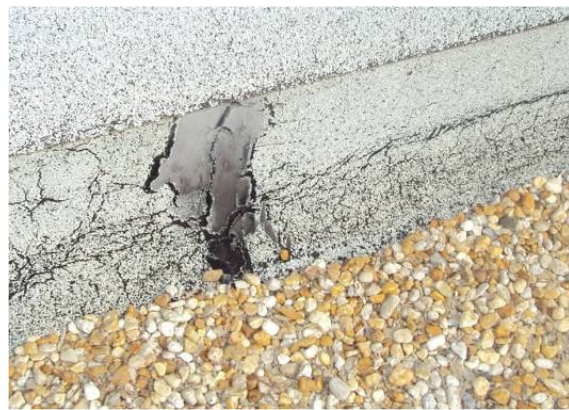
12. The sealant at the laps in the base flashings is deteriorated.

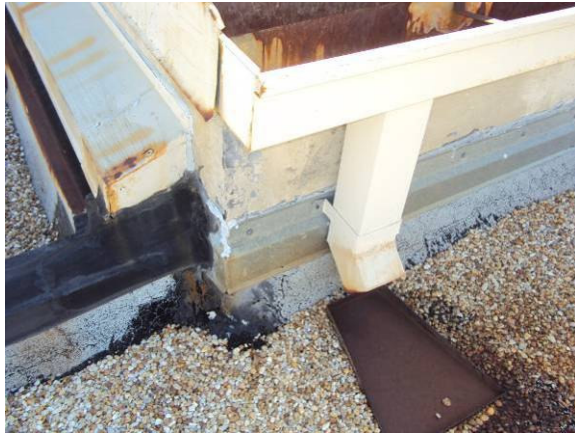
13. The expansion joint junction at B and F and the counter flashing at B and C are deteriorated.

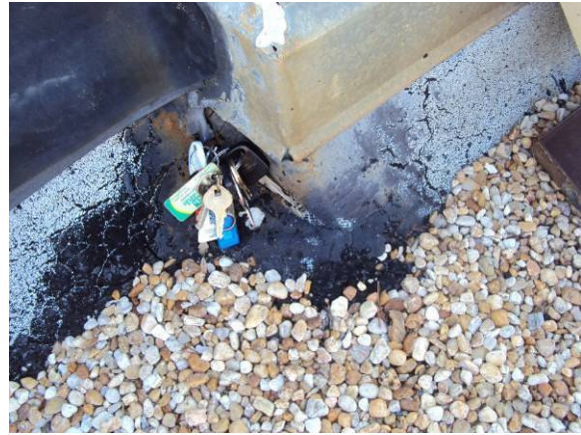
14. The base flashings in this location have open voids.

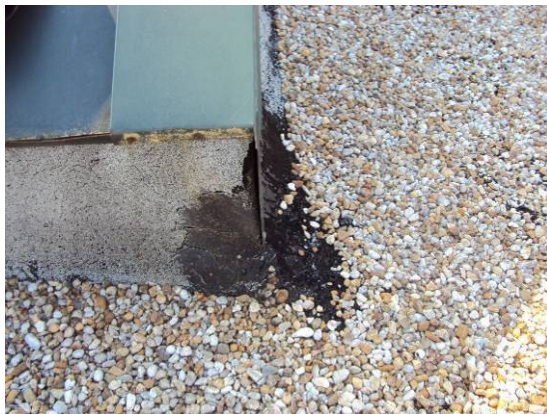
15. Repairs made to the base flashings near the metal roof areas.

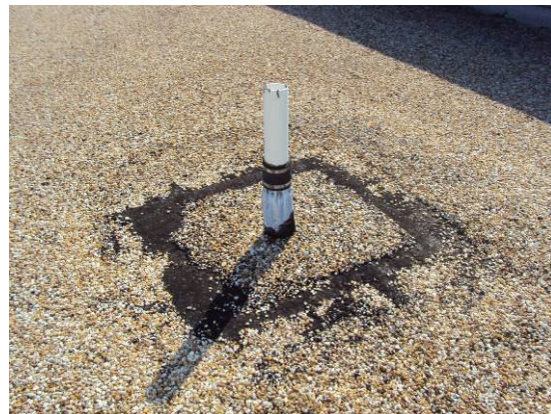
16. Repairs made at pipe penetration.

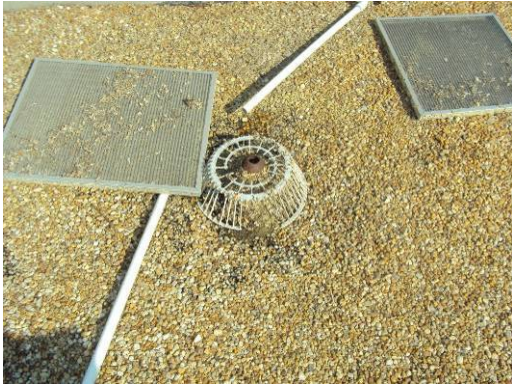
17. Plastic drain strainers are cracked and loose throughout Roof Area B. This drain is believed to be the cause of the leak shown in photograph # 1 and # 2.

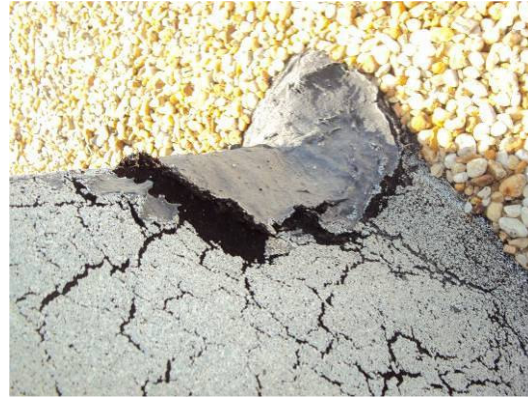
18. Open flashing lap.

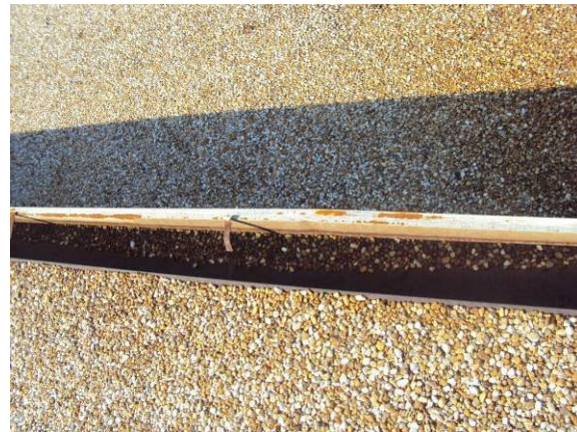
20. The gutter and gravel stop at Roof Area C are rusted and deteriorated.

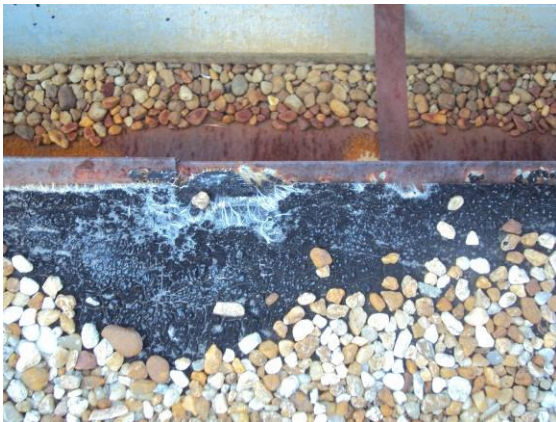
21. Roofing felts are exposed and deteriorated at the gravel stop.

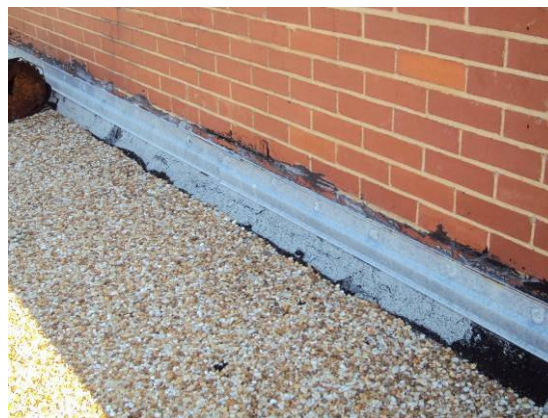
22. Sealant above counter flashings is deteriorated.

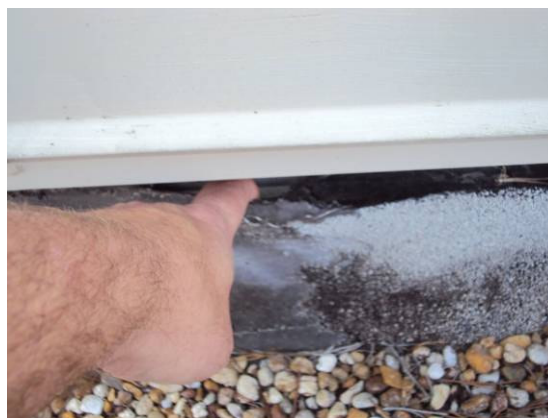
24. Base flashings are not secured and are open to water infiltration.

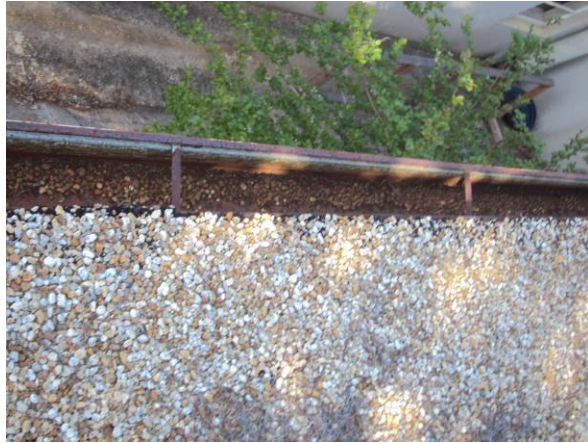
25. The gutters at Roof Area D are rusted and generally in poor condition.

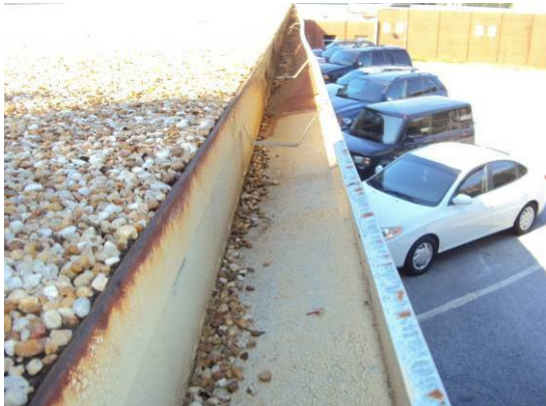
27. The gutters and gravel stop at roof area E are generally in poor condition.

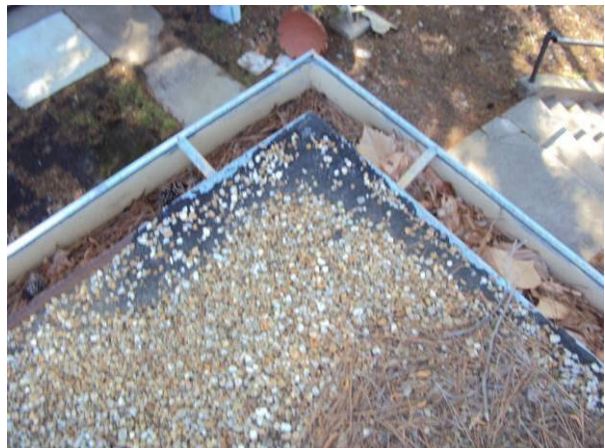
28. Debris is present in the gutters.

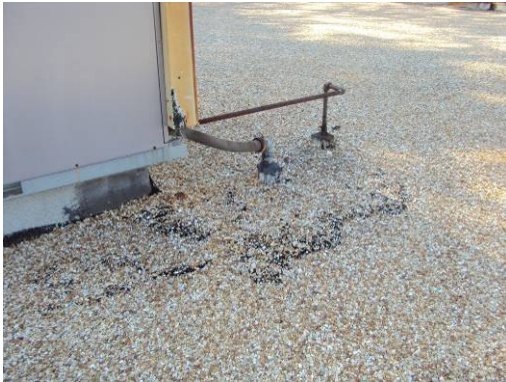
29. Pitch pans are beginning to crack. Also visible is a large repair around a roof top unit.

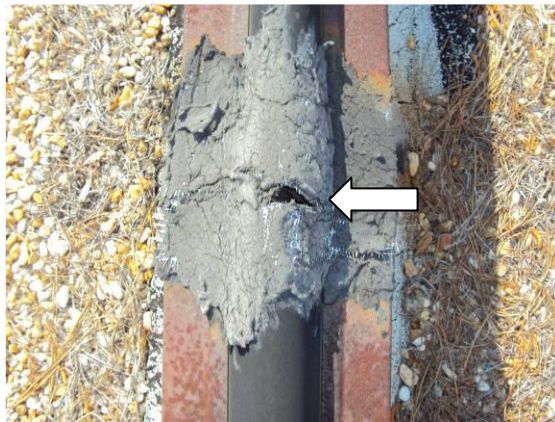
30. Open hole in expansion joint cover. Previous cement repairs have failed at this location.

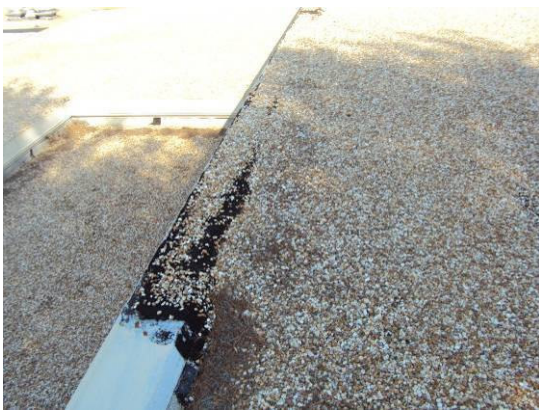
31. The juncture between a parapet wall and gravel stop is generally in poor condition.

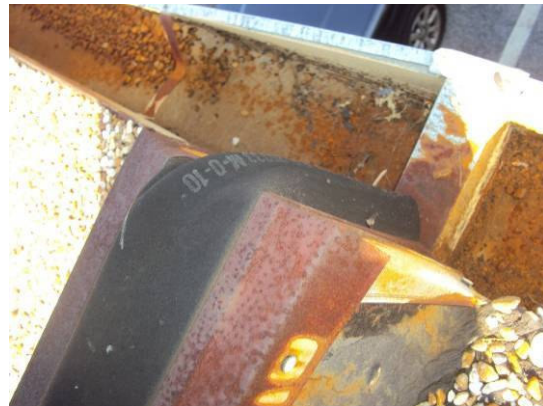
32. The expansion joint closure is poorly executed. Gutters and expansion joint cover are rusted.

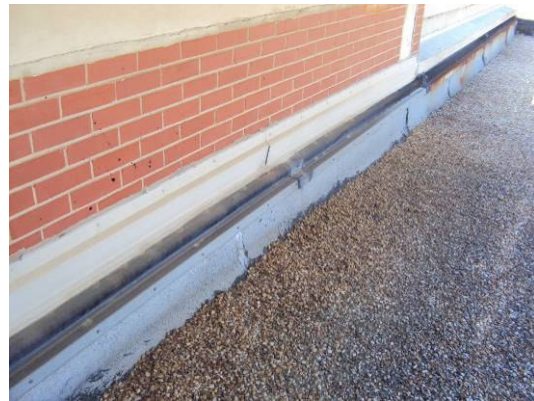
34. The expansion joint and base flashings between areas C and F are generally in fair condition.

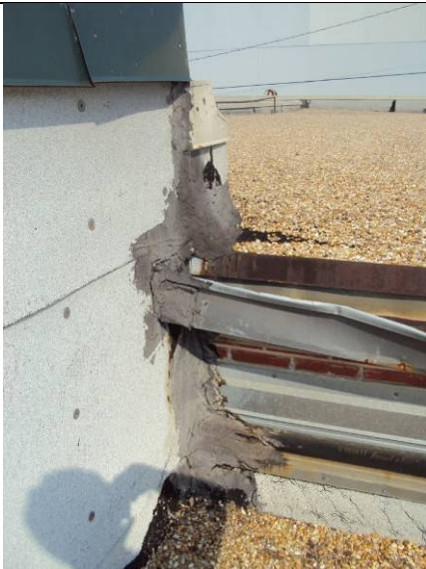
35. Bituminous cement repairs at the juncture of roof areas F and G.

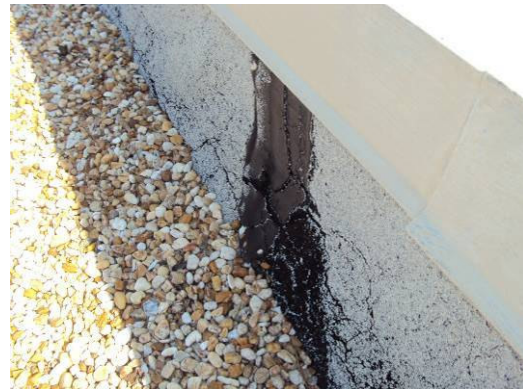
36. Open base flashing lap.

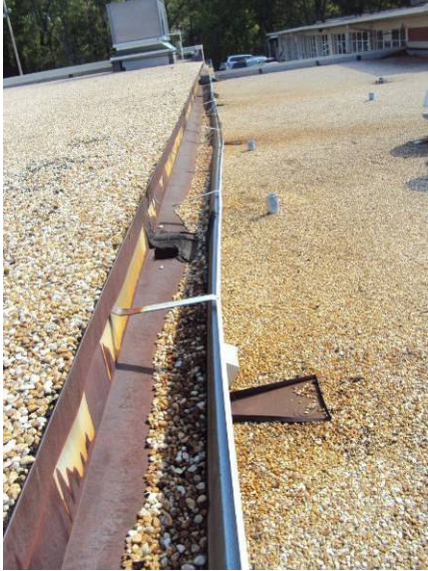
37. The gutters at Roof Area G are rusted and deteriorated.

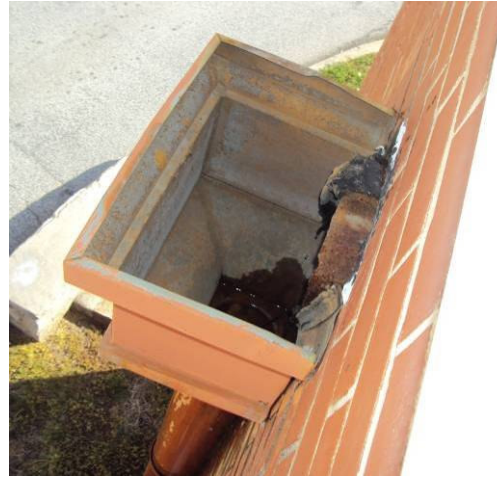
38. The conductor head and downspout is rusted.

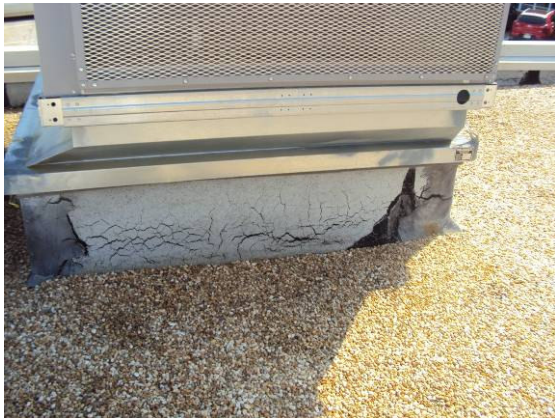
39. The base flashings on the roof top units show signs of stress cracking and deterioration at the laps.

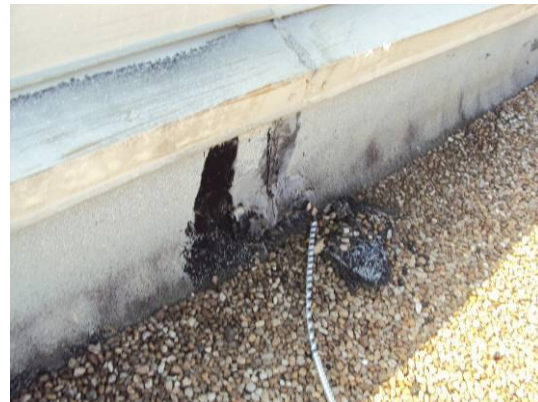
40. Bituminous cement repairs at base flashing laps.

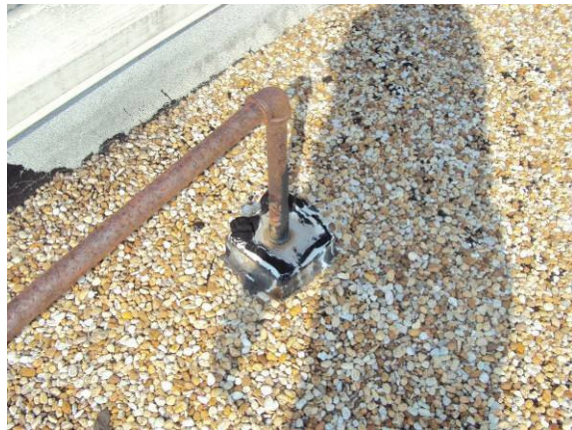
42. The pitch pans are not adequately filled.
Gas lines are rusted.

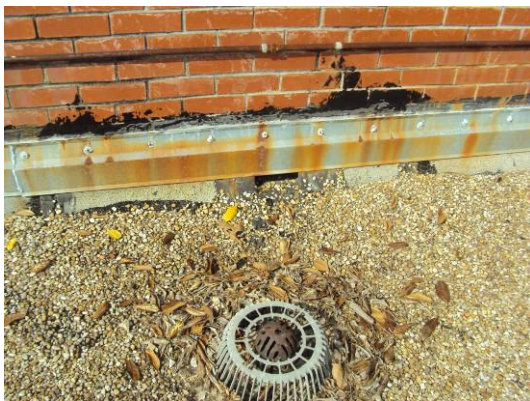
43. The surface mounted counter flashing is beginning to rust.

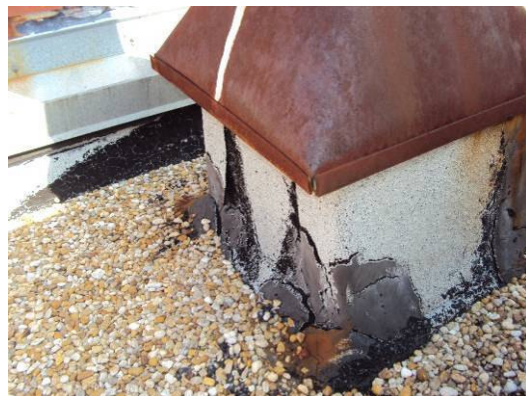
44. Bituminous cement repairs at membrane base flashings. Vent hood is rusted.

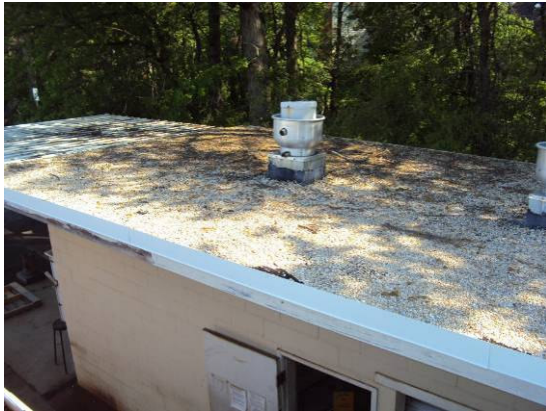
45. A fascia board at Roof Area I is deteriorated.

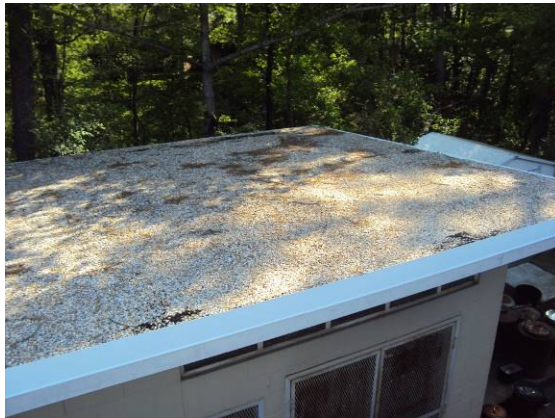
46. The gravel stop at Roof Area I is generally in fair condition.

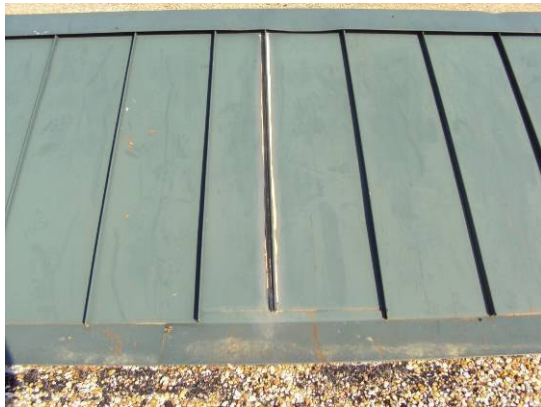
47. Repairs made to the metal roof panels near Roof Area A.

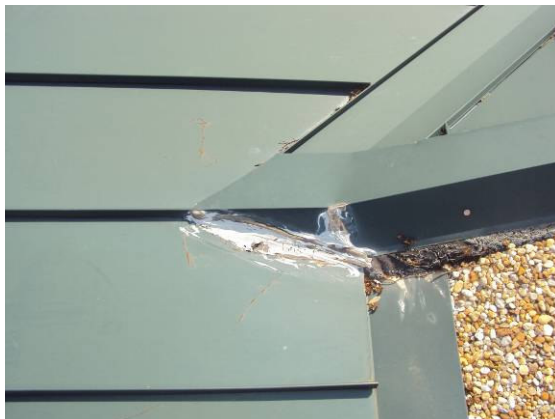
48. Sealant repairs made to the metal roof juncture at Roof Area A.

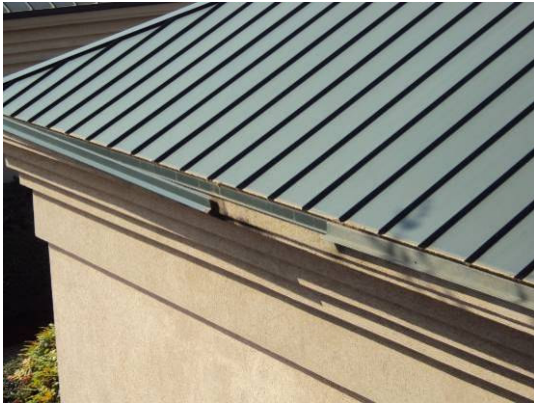
49. The fascia metal has come loose near Roof Area B.

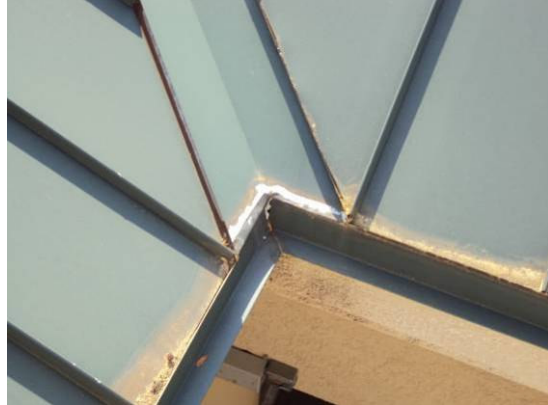
50. Water appears to be ponding in the valleys. Sealant repairs have been made in this area.

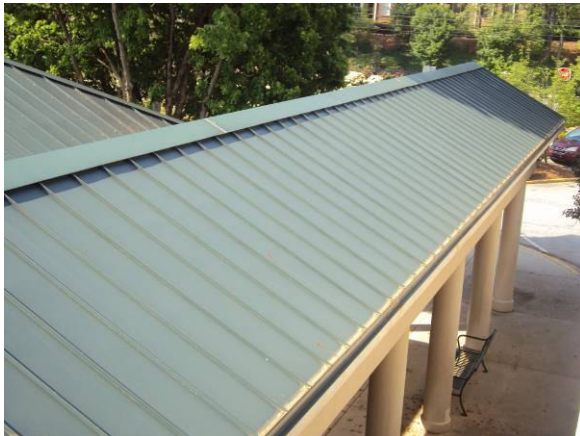
51. The metal roof area at the entrance appears to be in good condition.

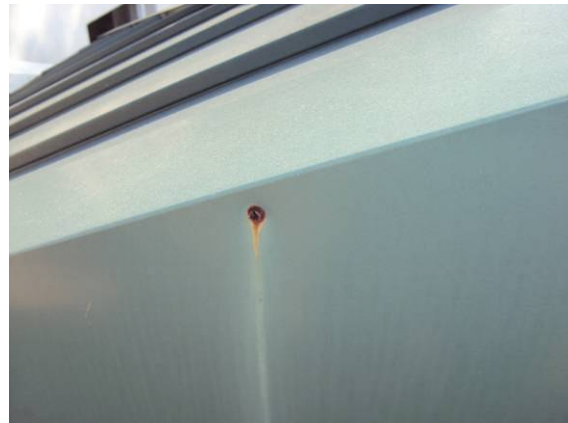
52. Exposed fasteners are rusted.

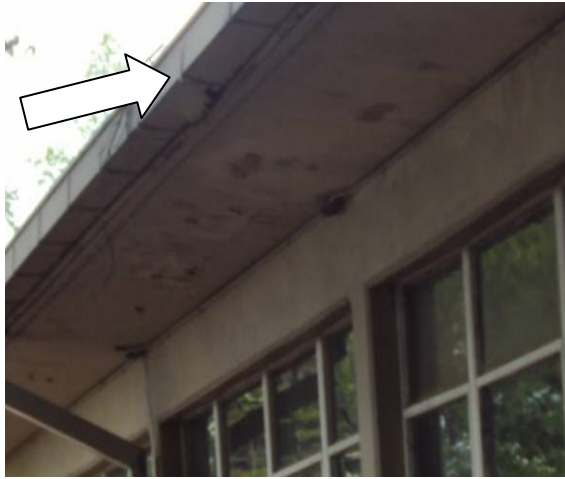
53. The soffit at Roof Area E is stained. The gutter is deteriorated at this location.

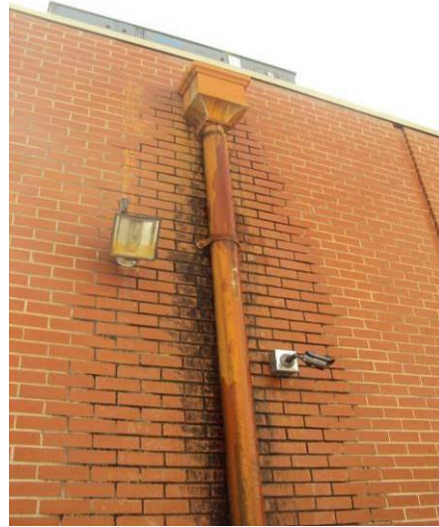
54. The conductor head and downspout are leaking at this location.

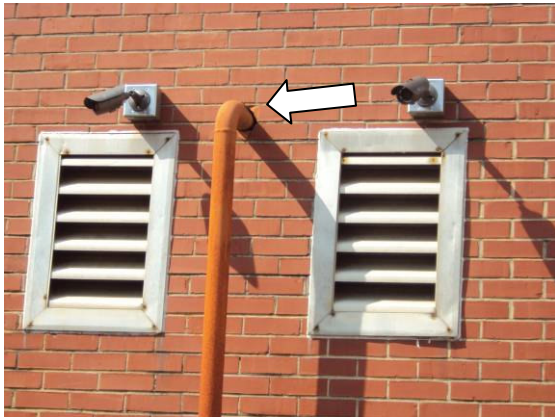
55. Pipe penetration not sealed at Area H.

Mildew stains were observed at a few locations on the exterior walls at scupper locations. Instances of missing caulking at through wall pipe penetrations were observed. We recommend proper sealant be applied at locations where pipes penetrate the walls.

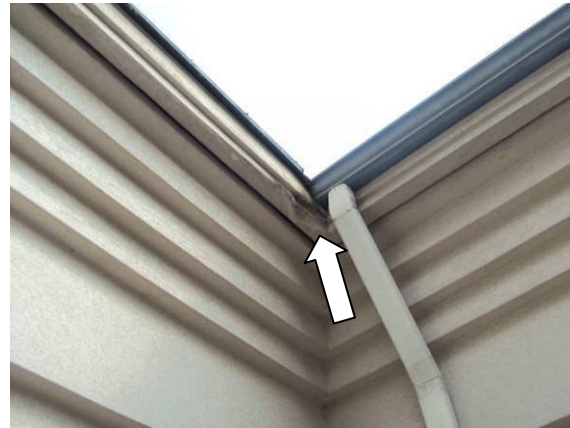
56. The EIFS is deteriorated at Roof Area A near the entrance.
